Portfolio of Conservation Projects

Mark Erdmann

Erdmann Art Conservation, LLC

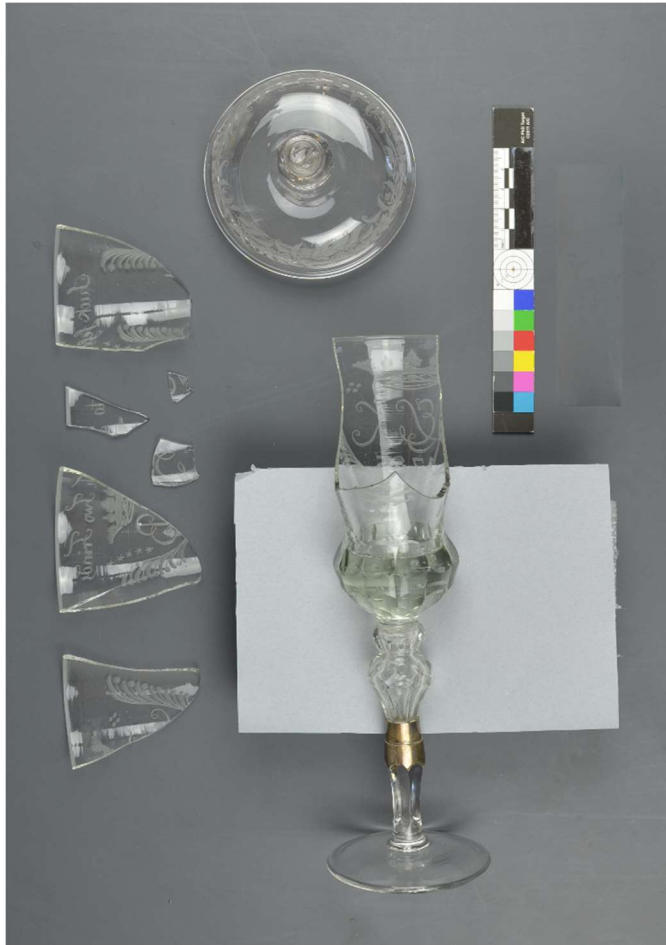
Before Treatment:

This pokal is on open display in an historic South Carolina stately home, and was a gift from British officers to the original owner during the Revolutionary War. It was broken during off-season storage, and all but one fragment were retained. It was reassembled with HXTAL epoxy, and one triangular loss was recreated with HXTAL in a wax mold. Etched details were recreated in the epoxy fill using diamond burs on a rotary tool.

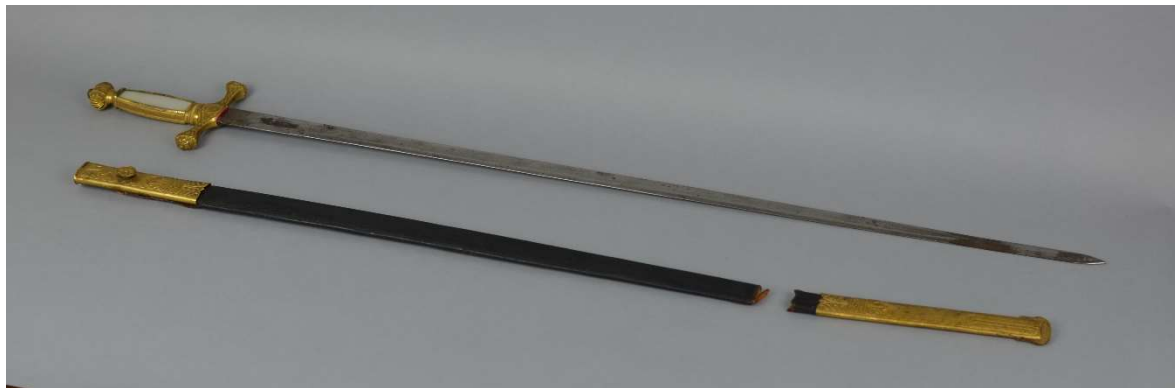
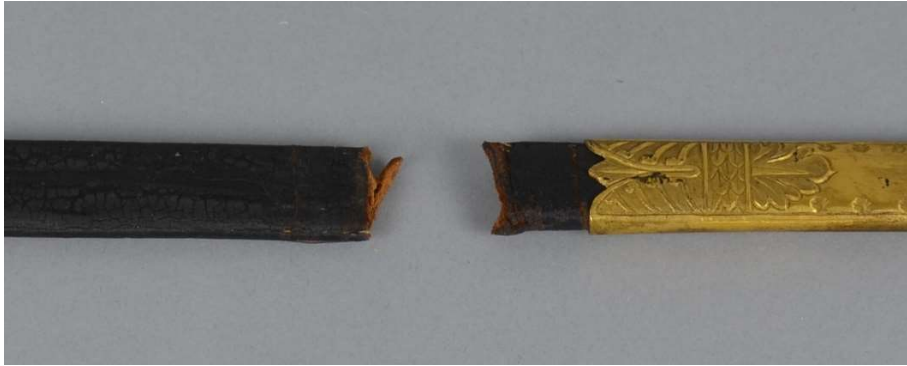
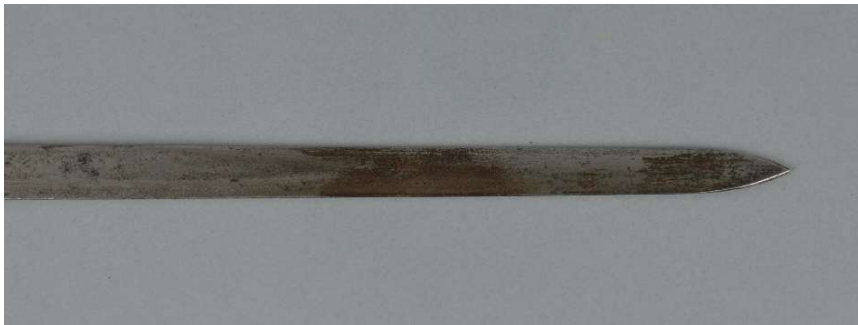
The sword is owned by the great, great grandson of the original owner, who plans to display it in his home beneath a portrait of his ancestor. The leather scabbard was broken into two pieces, with small losses along the break edge. The leather was distorted at the break edges. The sword blade had several areas with severe corrosion, and the gilt bronze grip had patches of discolored adhesive.

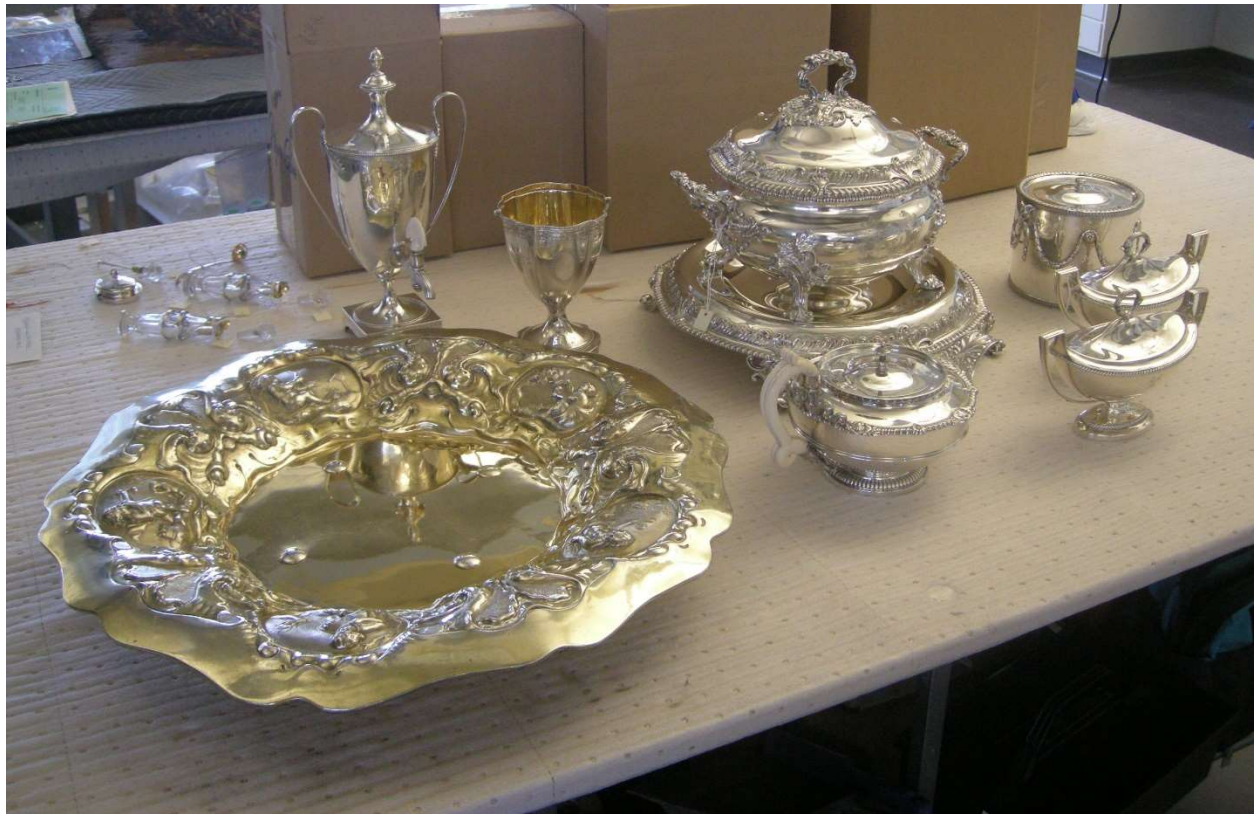
This project involved over 100 objects damaged in an attempted theft from a museum in which the silver objects were forcibly removed from glass display cases by smashing the glass, and then placing the objects in plastic garbage bags. Damage included dents, scratches and gouges caused by shards of glass impacting the silver, as well as sharp corners of objects impacting other objects. Mr. Erdmann evaluated the collection on site, and created a spreadsheet to categorize the level of damage, the estimated cost of treatment, and the type of damage. A prioritized list was created based on importance to the collection, extent of damage, and budget.

Treatment included dent removal with custom silversmithing stakes and mandrels, polishing to remove scratches, and laser welding to add silver in deeply gouged areas. The photo below represents a small sample of some of the objects treated.

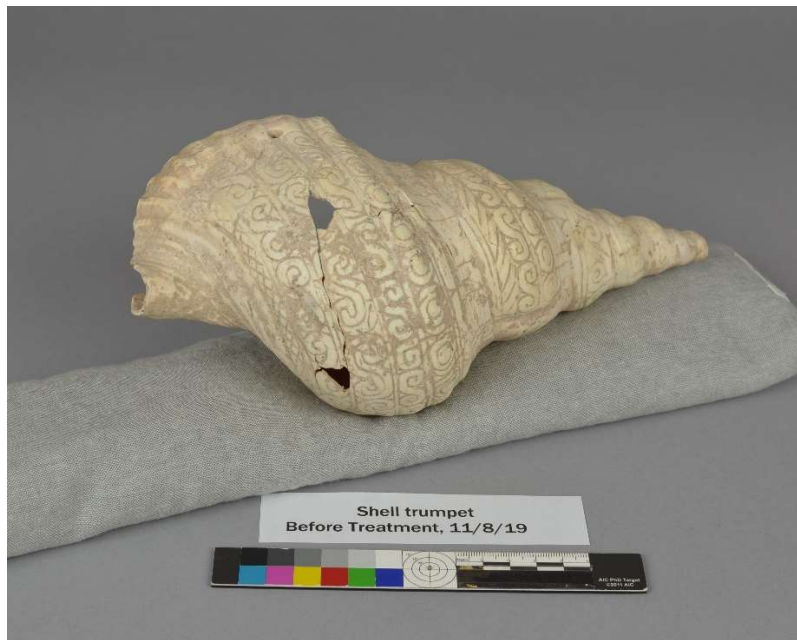
Before Treatment

This pre-Columbian ceremonial shell trumpet, dating between 900-1500 CE had numerous cracks and several large losses that made the object risky to handle, and distracted the eye from the carved geometric patterns. The cracks and losses were reinforced from the back with Japanese tissue and Paraloid B-72, then fills were made on the front using bulked and pigmented Aquazol 200. The fills were carved to complete the geometric designs, and inpainted to match the aged original surfaces.

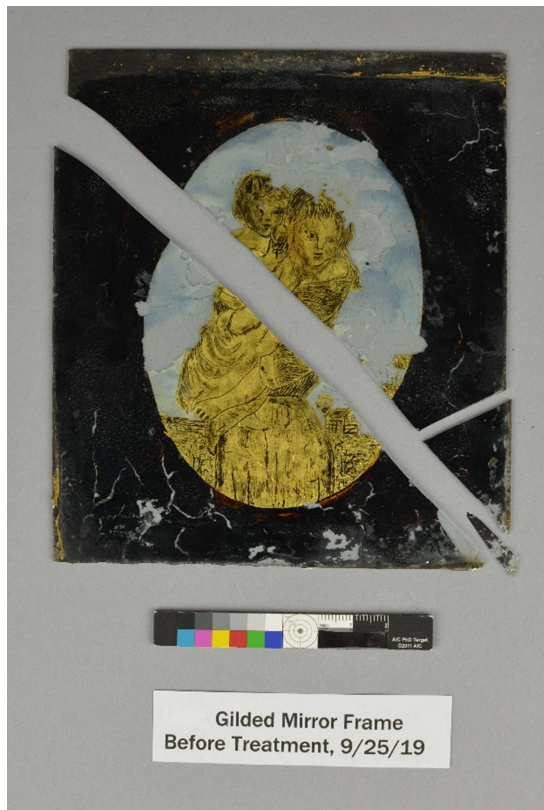
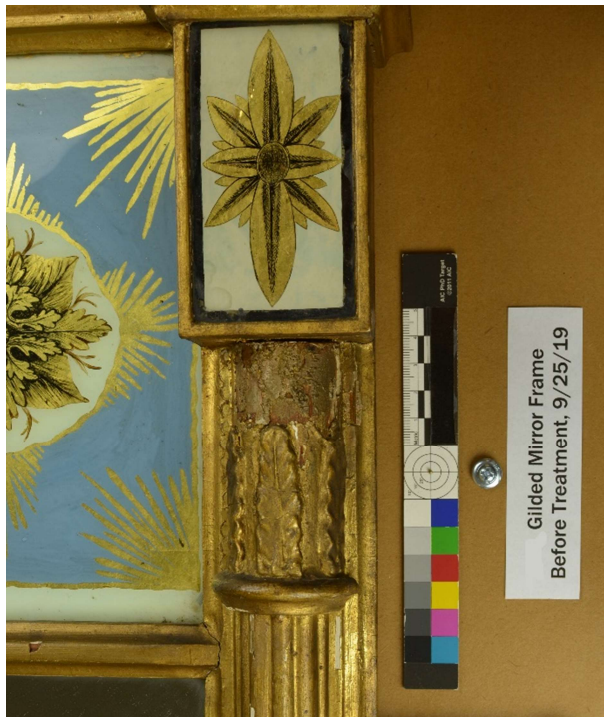
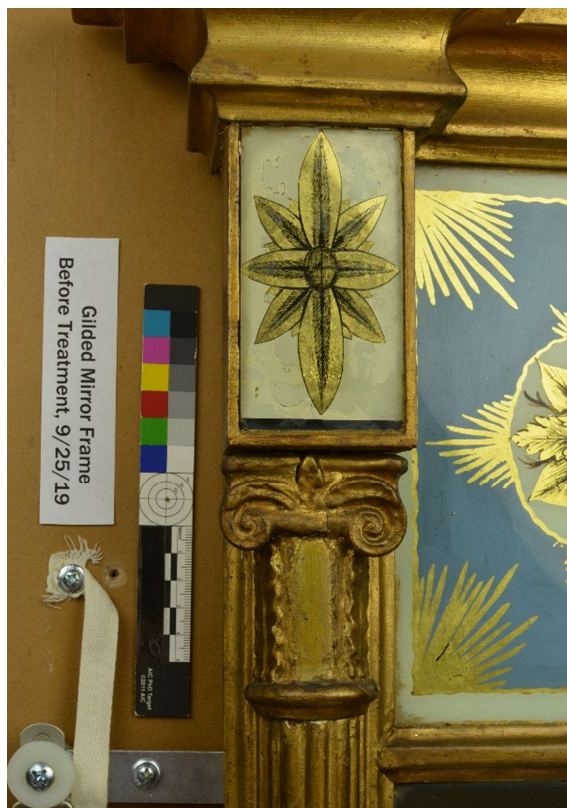
This large gilded mirror frame had numerous losses in its surface including cracked and flaking gesso and two decorative elements. The central reverse painted glass panel was broken into three pieces and had paint loss from the image. The gesso and gilding losses were consolidated with heat activated adhesive, losses were filled, and inpainted with color-fast gold acrylic paint. The lost decorative elements were reproduced by making molds of identical intact elements. The broken glass was adhered with HXTAL epoxy and the flaking paint consolidated. Lost gold paint was inpainted directly onto the reverse of the glass using 23.5 K gold watercolor. Losses in the blue sky areas were compensated for by painting on a piece of mat board placed behind the glass. The framing around the panel was rebuilt and the panel held in place with custom made brass clips, toned to the color of the surrounding wood.

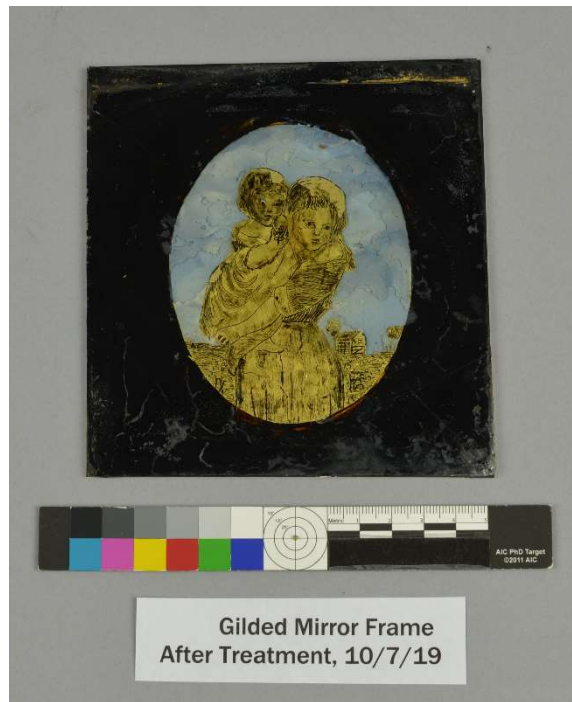
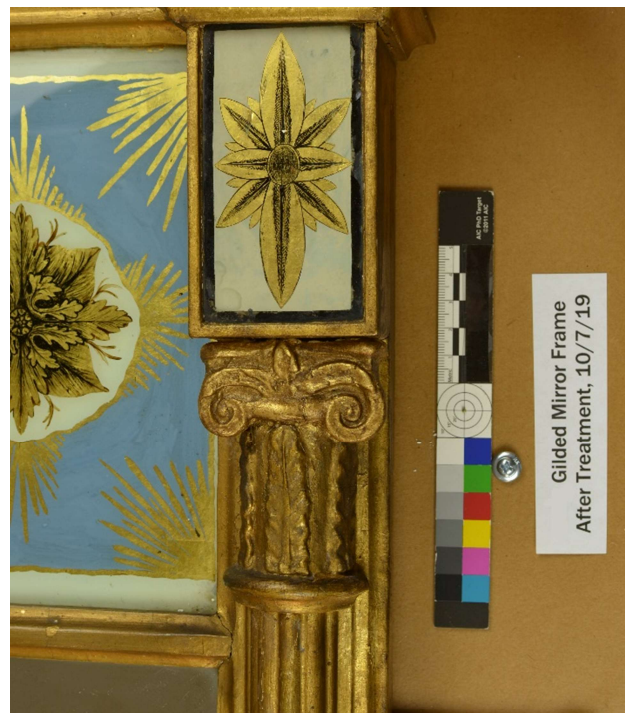
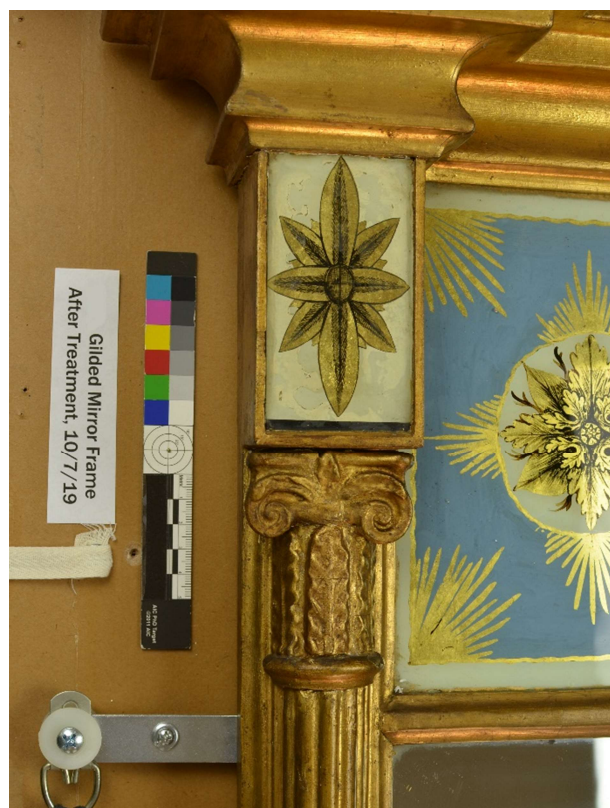
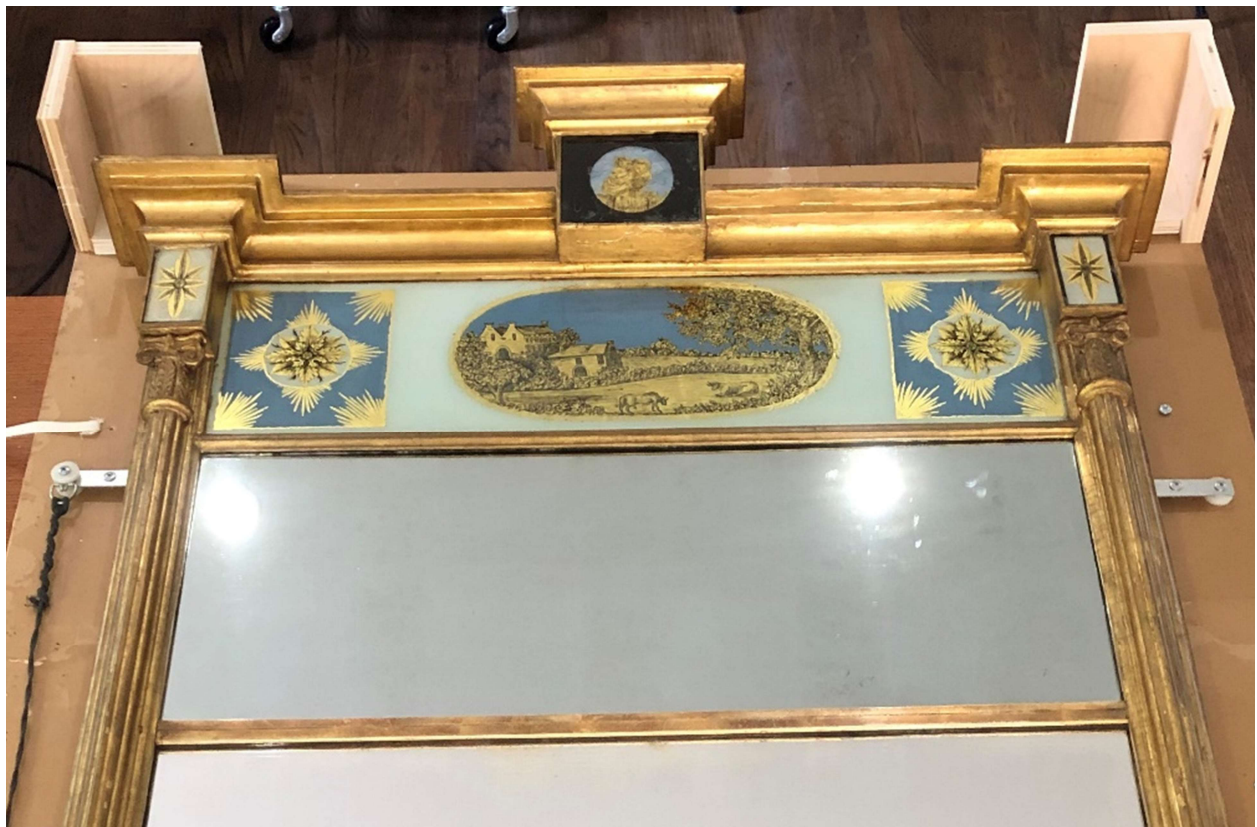
After treatment with central glass panel in place

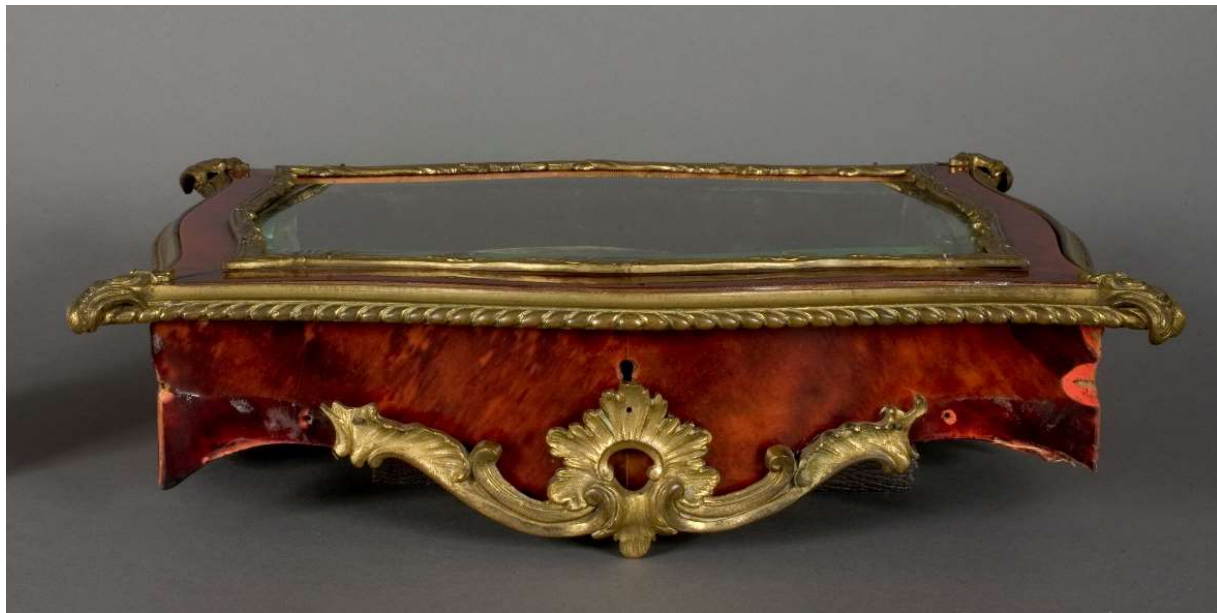
This jewelry box is a wood box with tortoise shell veneer over a red ground, beveled glass top, velvet interior and ormolu legs and trim. It was damaged during an attempted theft which left the legs severely distorted and broken loose, the corners of the wood box splintered and losses to the veneer.

Box – note damage to tortoise shell veneer at right and left sides

Loose pieces of tortoise shell veneer were adhered with a 40% B-72 solution in acetone. Golden fluid acrylics were used to recreate the existing red ground layer. To imitate the veneer, pigmented wax fills were made with a heated spatula to achieve translucency and appropriate thickness. Gamblin conservation colors with additional resin were used to imitate the veining on the veneer and a similar gloss.

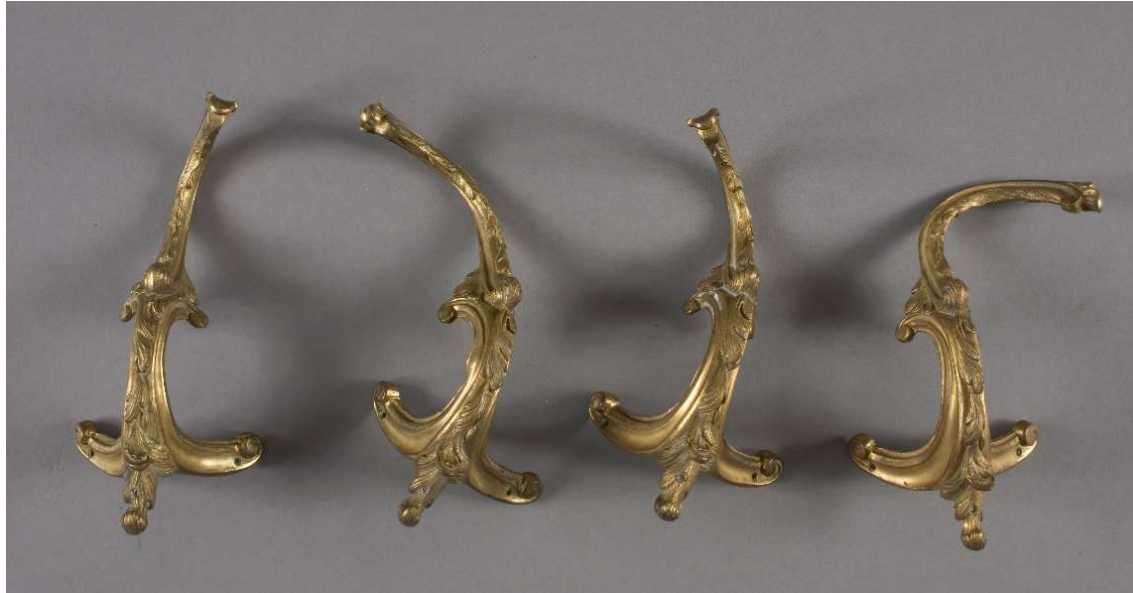
Legs after removal from box, before annealing and reshaping

The bent legs were removed from the box, annealed and reshaped using custom made jigs, clamps and other silversmithing tools. After reshaping, the legs were coated with colored lacquer to restore the color of the original ormolu, and were re-installed with new brass escutcheon pins.

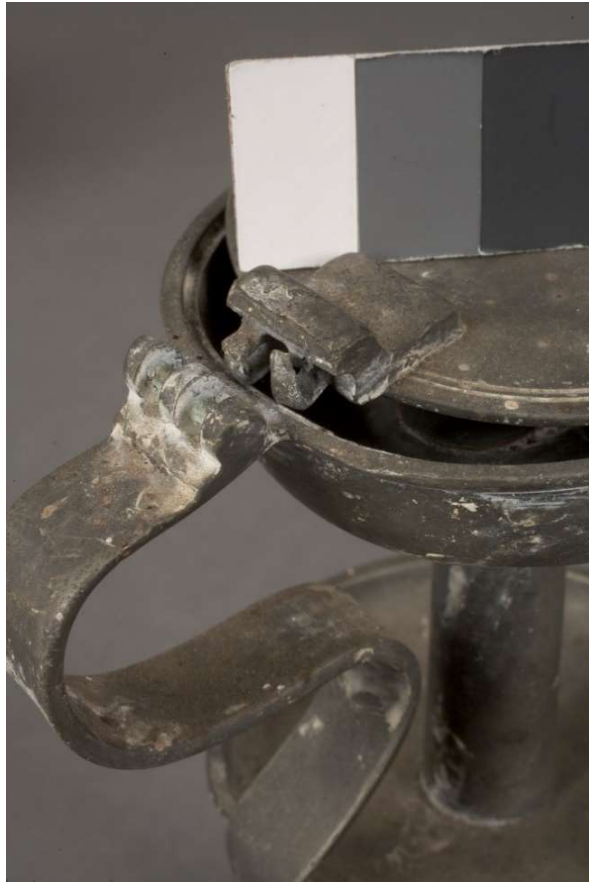
Before Treatment:

The hinge lugs were thinned and broken through repeated use. Since the object is displayed in a home and is accessible to family and visitors, it needed to be functional. The missing hinge lugs were built up by soldering additional material onto the existing lugs, followed by shaping with hand tools. The repaired areas were chemically patinated, and the hinge pin reinstalled.

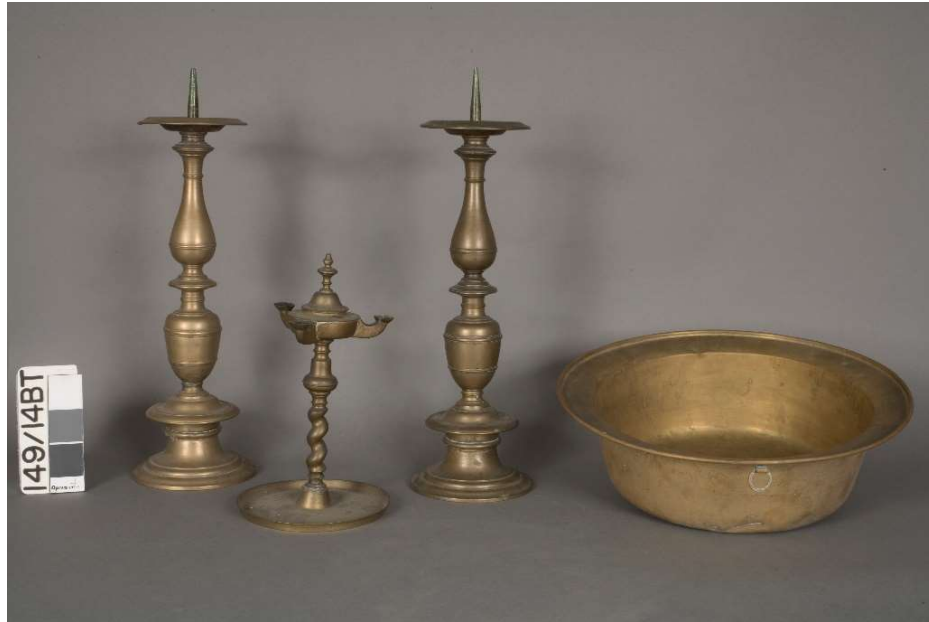
Before Treatment:

These brass decorative objects are on open display in an historic home that is still occupied by the descendants of the original owners. The tarnished and battered appearance was not compatible with the way the collection is interpreted, and the loose stem on the oil lamp created a risk of further damage. The loose stem was repaired by reactivation of existing low temperature solder. Dents in the large basin were removed by manipulation over polished steel and wood mandrels. The objects were polished with a slurry of calcium carbonate and ethanol, followed by spray application of Agateen lacquer.

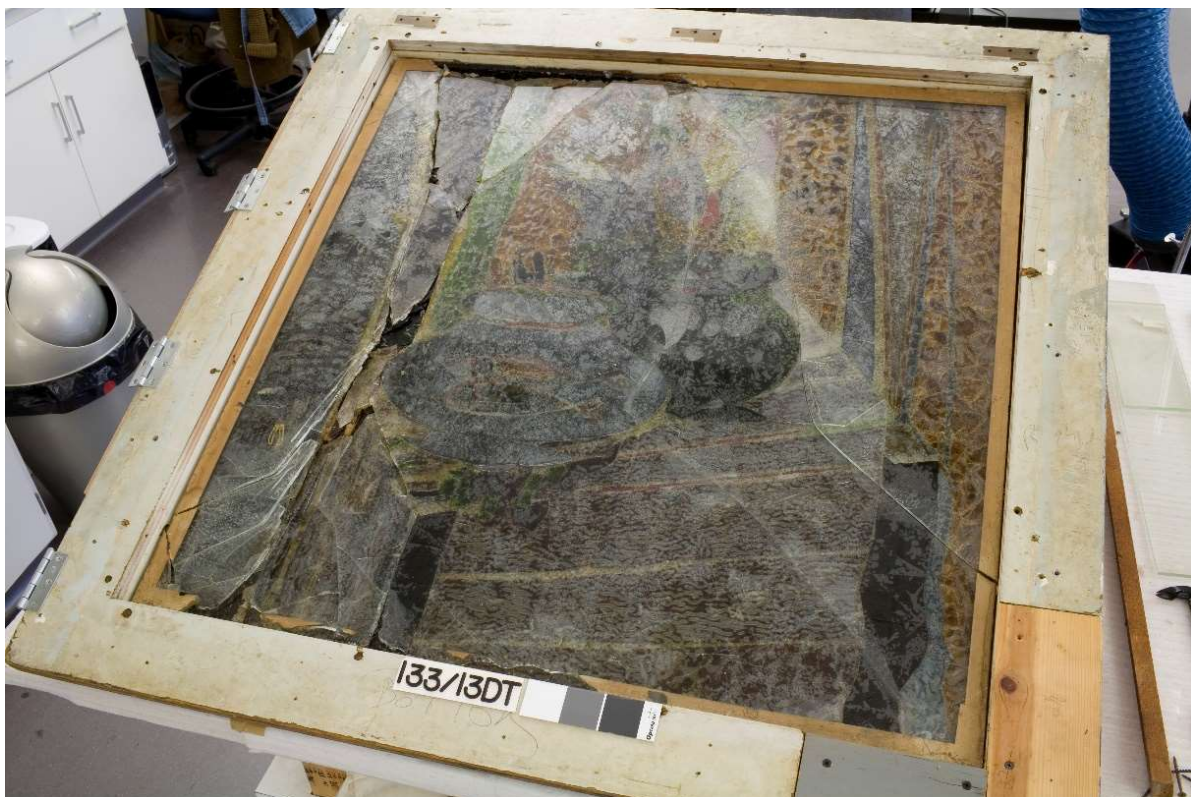
Before Treatment:

Gemmail is a type of stained glass art developed during the 1930s by French painter Jean Crotti. It differs from traditional stained-glass techniques in that the individual pieces of colored glass are not joined by lead came, but overlapped and glued together with a clear resin. These heavy glass mosaics were meant to be displayed with back-light, and many, including this example, had built-in electric light sources. This Gemmail depicts George Braque's painting, *The Packing Case*, and suffered a major impact, breaking the plate glass support, and dislodging many of the individual glass pieces. The owner wished to display it with a low profile, low-heat light source.

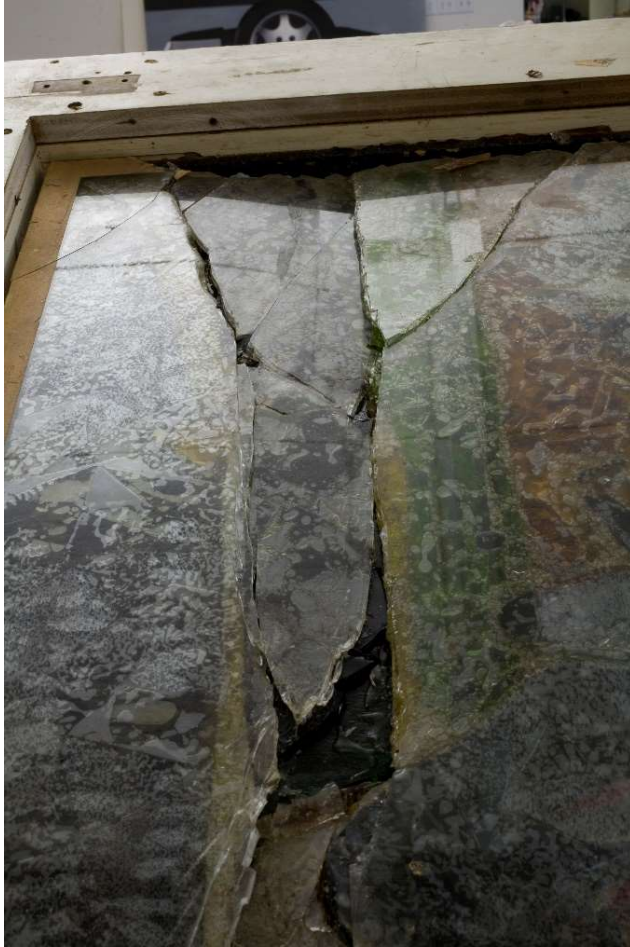
Detail of planar distortions in glass support

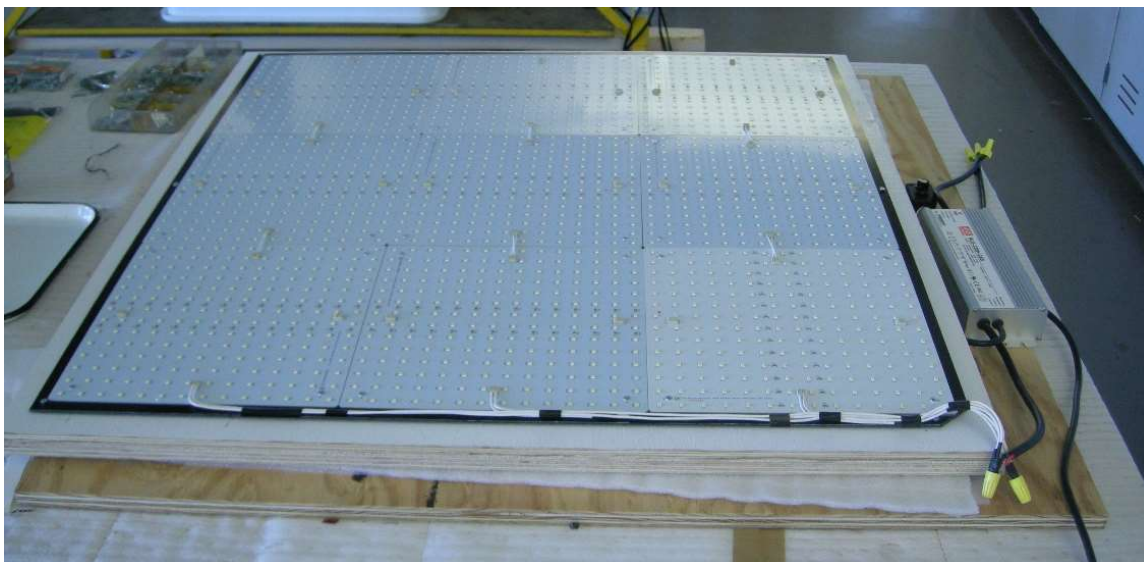
LED light panel built into the new framed wood enclosure

A new wood enclosure and frame was designed and built by ICA technician, Chris Pelrine, and fitted with an LED light system by CREE, and implemented by Mr. Erdmann.

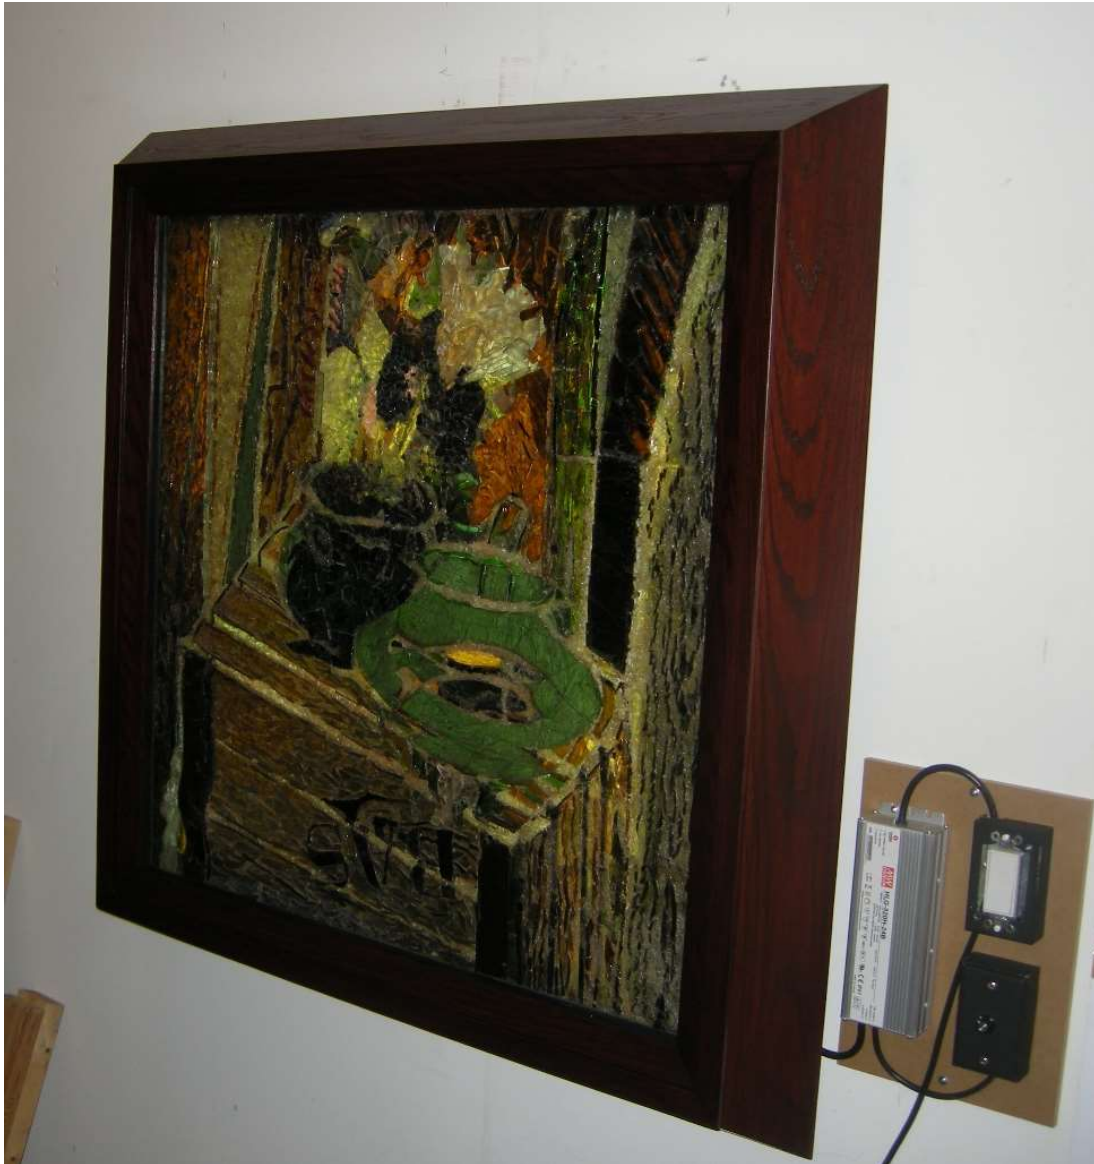
Gemmail after treatment with new frame and light source

The gemmail was removed from the existing wooden frame, and disassembled into smaller fragments in order to lay it flat on a new glass substrate. It was dry fit together and then held in place with small circles of clear silicone adhesive. Loose glass pieces were relocated using images of the original painting to recreate the image. Missing pieces were created by breaking up new pieces of colored glass to match the original. Pieces were adhered with B-72 in acetone.

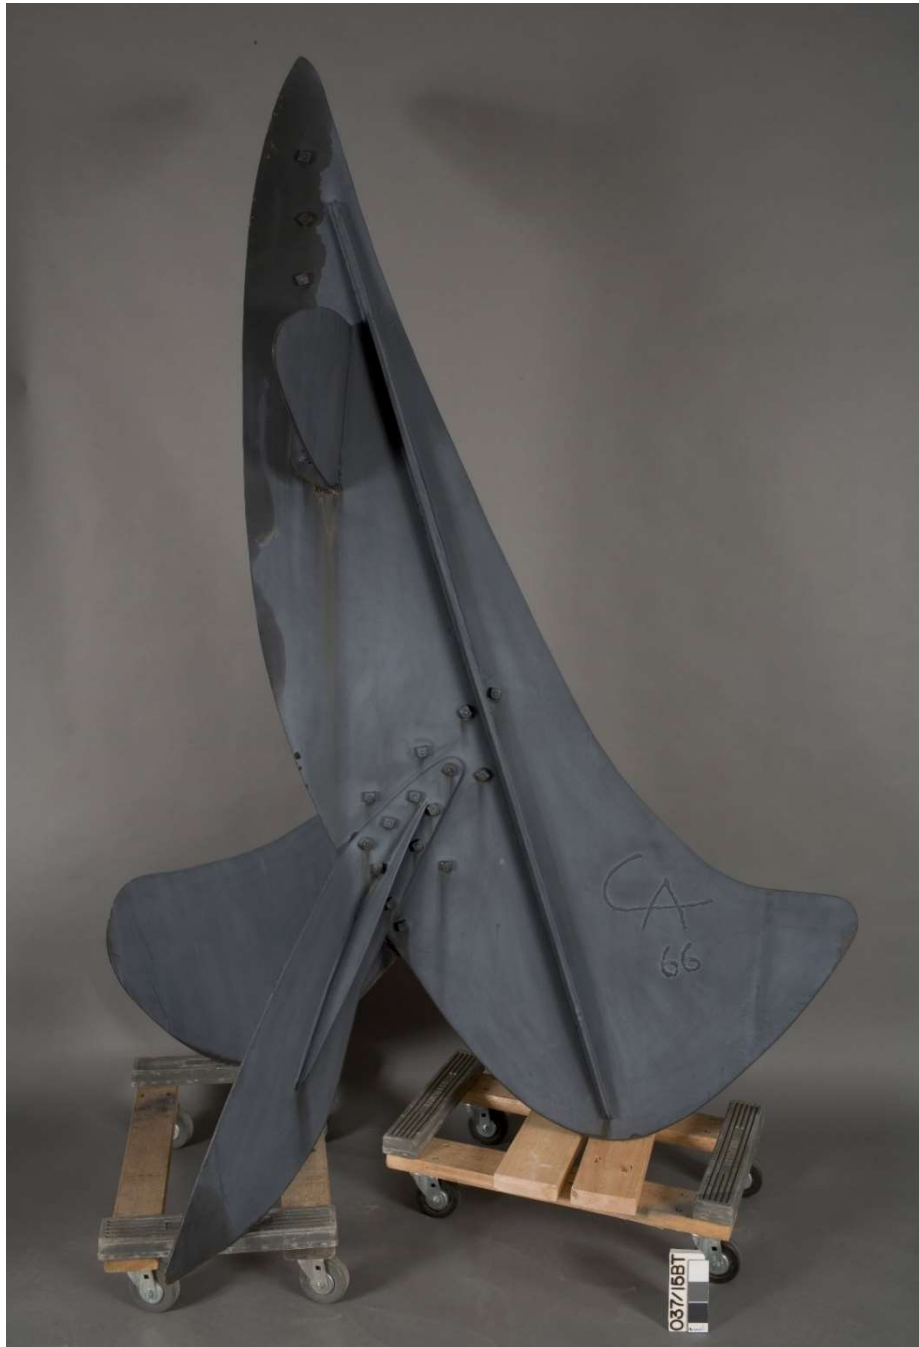
Before Treatment:

Tadpole is a painted steel sculpture known as one of Calder's stabiles, and displayed outdoors by a private collector. The matte black paint had become very chalky, there were corrosion streaks extending down from the bolted connections, and areas of blistering paint due to underlying corrosion. The sculpture was disassembled, and the paint removed by blasting with glass bead media. A three-step paint system approved by the Calder Foundation was spray applied to the separate components prior to reassembly. The first coat was a zinc-rich epoxy primer, followed by an iron oxide epoxy primer, and finally a catalyzed polyurethane topcoat with a gloss level of 11-14 gloss units at 60°. A final topcoat was applied after assembly.

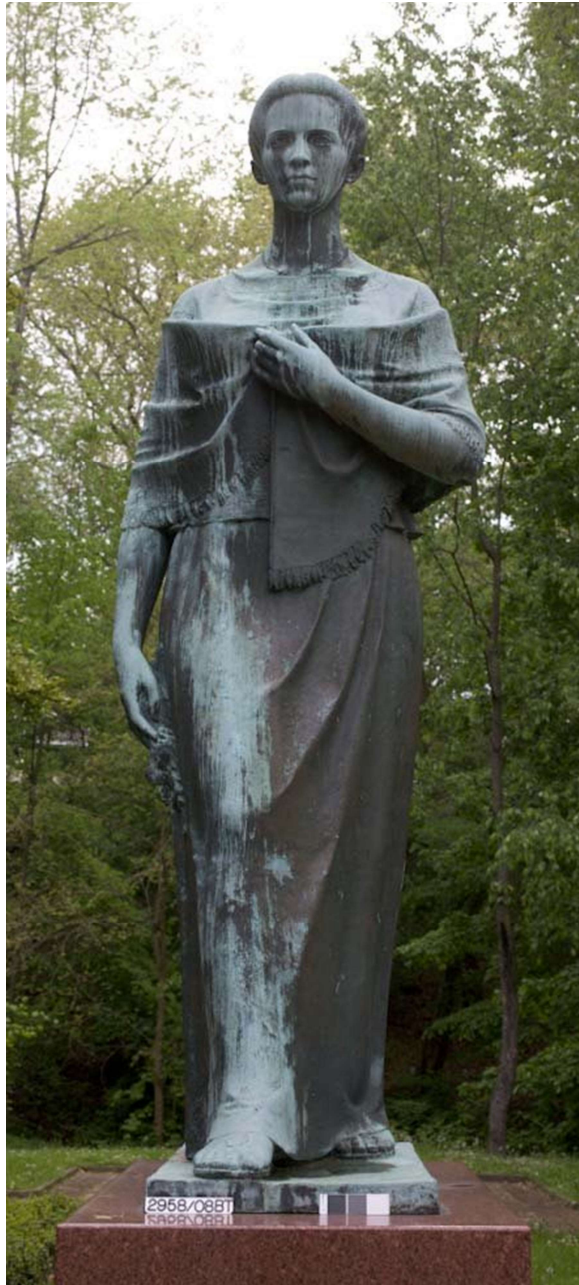
Before Treatment

This larger-than-life bronze sculpture stands on a red granite plinth in the Ukrainian cultural garden in Cleveland's cultural gardens. Installed in 1956, but not properly maintained, it had lost its original patina, and become disfigured with sulfate crusts and copper corrosion products. It was cleaned to bare metal by glass bead blasting, followed by re-patination with ferric nitrate and sulphurated potash. A protective coat of wax was applied with heat to allow the coating to melt over the surface, filling porosities and crevices in the bronze. After two years, the sculpture was washed and coated with cold paste wax as a routine maintenance coating.
